Retrieval of a broken instrument using ultrasonics under magnification: A case report

ABSTRACT

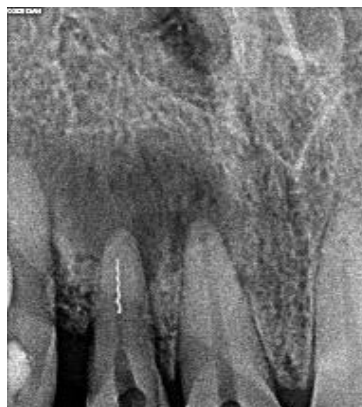
Fig. 1: Pre-op radiograph with fractured file at apical third

A 40-year-old female patient reported to the Department of Conservative Dentistry and Endodontics, Post Graduate Institute of Dental Sciences, Rohtak with the chief complaint of pain in upper front right tooth region. She gave a history of root canal treatment with the same tooth at a private clinic, 9 months back. Clinical examination access opened 12 and 11 with open canals. The tooth was tender on percussion. Intraoral periapical (IOPA) revealed a fractured instrument at the apical third of 12 with unobturated canal (Fig 1). A big periapical radiolucency was observed in relation to 11 and 12.

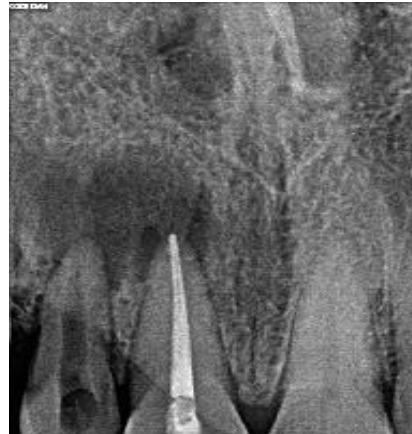
Fig. 2: Radiograph after removal of file

Instrument retrieval was planned after the patient was explained about the treatment plan and consent obtained. Peeso reamers were used to prepare a staging platform, and coronal part of the broken instrument was exposed by removing the surrounding dentine. Ultrasonic tip ET25 (Satelec Acteon, France) was used to trephine around the fragment. The procedure was carried out under an operating microscope at 2.5X magnification. The ultrasonic tip ET25 was activated at a power setting 6 to trephine dentin around the broken fragment. Canal was irrigated with normal saline intermittently to flush out the debris from the canal. The file loosened and was retrieved. IOPA was taken to confirm the removal of the separated instrument (Fig. 2). Working length was then determined, and cleaning and shaping of the root canal system were performed using stainless steel hand files. Obturation was done and the tooth was restored with composite restoration (Te-Econom, Ivoclar Vivadent). A radiograph was taken (Fig. 3).

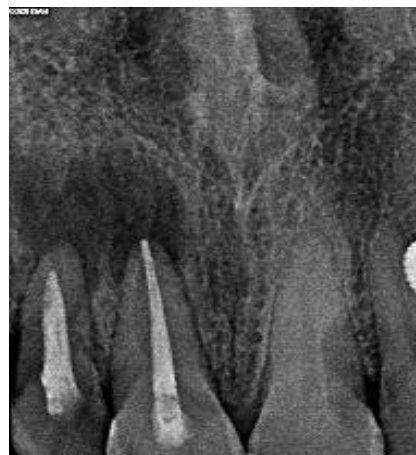
Fig. 3: Radiograph after cleaning, shaping and obturation.
