Ultrasonic's Mediated Retrieval of a Broken Round Bur in the Root Canal of Lateral Incisor – A Case Report

Keywords: Access Cavity Preparation; Straight Line Access; Retrieval

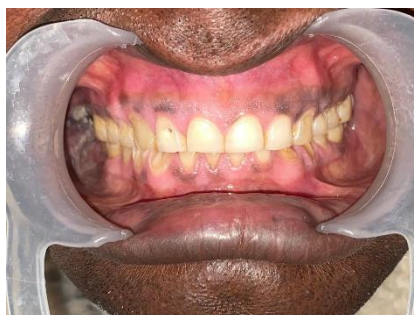
Figure 1- Temporary class 5 restoration w.r.t 22

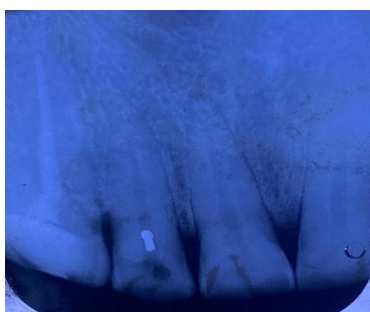
A male patient aged 34 years reported to the department of conservative dentistry and endodontics with pain in upper front tooth region with a history of incomplete root canal treatment by a general dentist. The patient had a medical history that was not relevant to the current condition. Clinical examination showed that the tooth was sensitive to percussion. There was no mobility, and the periodontal probing was measured within normal limits (<3 mm). The tooth had a class 5 temporary restoration on the buccal aspect of tooth 22 [Figure 1]. Radiographic examination showed a radiopaque root canal filling material in the coronal third, suggestive of a separated round bur. The periapical

radiographic examination revealed a wide coronal chamber. Further removal of the broken instrument did not seem to perforate the root. [Figure 2]

Figure 2- Round bur separated in coronal third region

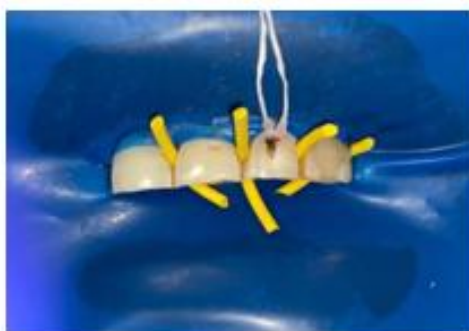
Figure 3- Access cavity preparation from cervical third region of tooth

After reviewing the treatment options with the patient, it was decided to proceed with nonsurgical endodontic retreatment. During the first appointment, after local anesthesia and rubber dam isolation, the temporary restoration was removed and it revealed that access cavity preparation was carried out from the cervical third region of tooth 21 suggestive of wrong approach, the access was further modified to attempt instrument retrieval. [Figure 3] A staging platform was created lateral to the separated instrument for placement of the ultrasonic tip. An ultrasonic tip (Satelec Acteon Group, Merignac, France) was inserted into the canal and activated for 1 minute without coolant. The canal was then irrigated with 2.5% sodium hypochlorite (NaOCl) to cool the working area and flush out debris. After multiple attempts, the instrument unwinded, loosened and got removed from the canal [Figure 4]. Canal was flushed with irrigants to remove the debris, working length was established and chemomechanical preparation was carried out with a combination of hand and rotary instruments followed by placement of calcium hydroxide as intracanal medicament. (Ultracall - Ultradent, Brazil)

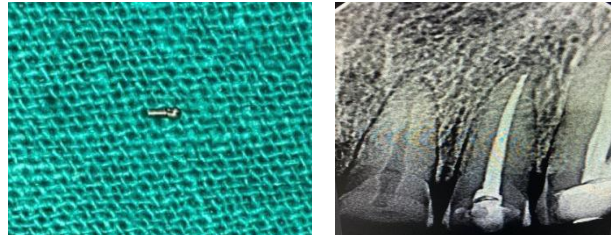
Figure 4- Bur retrieved from the canal Figure 5- obturation followed by permanent restoration

In the 2nd visit, the patient was asymptomatic with dry canals thus following the irrigation regime obturation was carried out using the cold lateral compaction technique and AH Plus sealer (Maillefer - Dentsply, Switzerland). [Figure

5].The access opening was sealed with a temporary restoration and the patient was referred to an operative specialist for the definitive restoration and a final radiograph was taken.
