Retrieving a Separated Instrument from the Root Canal: A Case Report

Dr. Anshu Singh¹, Dr. Sushma²

^{1,2}Department of Conservative Dentistry and Endodontics, PGIDS, Rohtak

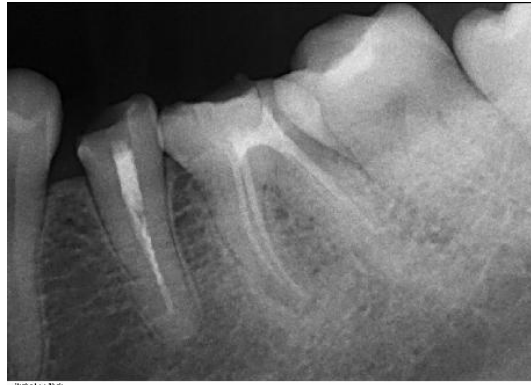
A 32-year-old female reported dull, continuous pain in the mandibular left back teeth region for 2 weeks. The patient gave a history of endodontic treatment one month back, but the pain was not alleviated. On clinical examination, the left mandibular second premolar with open access cavity and dislodged restoration was seen. The tooth was tender on percussion. The tooth was not associated with any swelling or mobility. On radiographic examination, an under-obtured second mandibular premolar with the separated instrument in the middle third of the root canal was observed. The periapical tissues were normal and not associated with any radiolucency or widening (Figure 1).

Figure 1 Radiograph show in gunderobtured canal and fractured instrument in the middle third of root canal of the mandibular left second premolar.

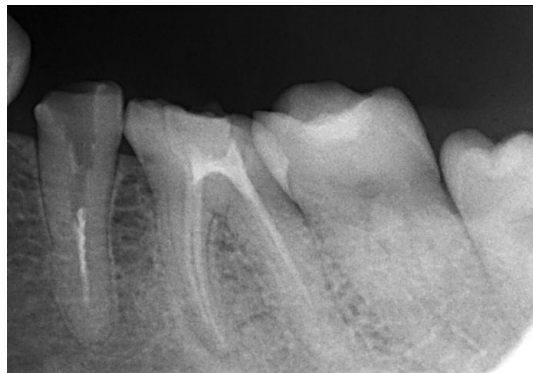
Figure 2) Removal of gutta-percha and the coronal portion of the fractured instrument is exposed.

A nonsurgical retreatment was planned, the patient was informed about the procedure and consent was taken. After administering local anesthesia, rubber dam isolation was done. The gutta-percha from the coronal third of the root canal was removed with Hedstroem-files (Dentsply International) and Gates-Glidden drills (Dentsply International) frequently irrigating with 3% sodium hypochlorite in the presence of GP solvent. The coronal portion of the broken instrument was visualized under a dental operating microscope (Carl Zeiss, Germany) at $\times 4$ magnification. Attempts were made to navigate past the obstruction using K-files (sizes 08 and 10, Dentsply Maillefer). However, these efforts were unsuccessful as the obstruction was firmly embedded in the root canal's dentin. To access deeper areas around the separated file, a staging platform was prepared using a modified Gates Glidden drill (size 3, Dentsply Maillefer, Ballaigues, Switzerland). This platform helped to expose the file and the surrounding dentin, enabling the use of smaller ultrasonic tips to trough deeper around the separated instrument (Figure 2).

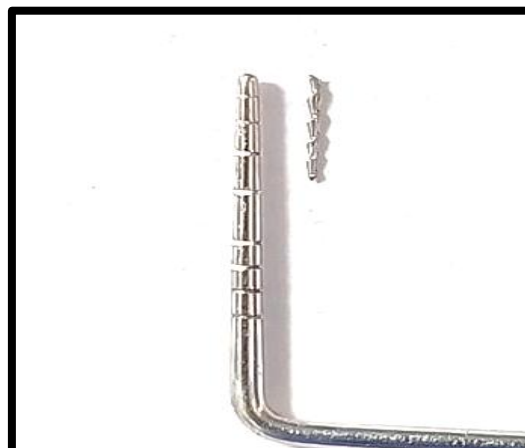
Figure 3) Fractured fragment of approximately 4.5mm in length

The ultrasonic tip ET25 was activated to trephine dentin around the separated fragment. Intermittent canal irrigation was done with Normal saline to flush out debris and act as a coolant. Approximately 10 minutes later, the fragment became dislodged and exited the canal (Figure 3)

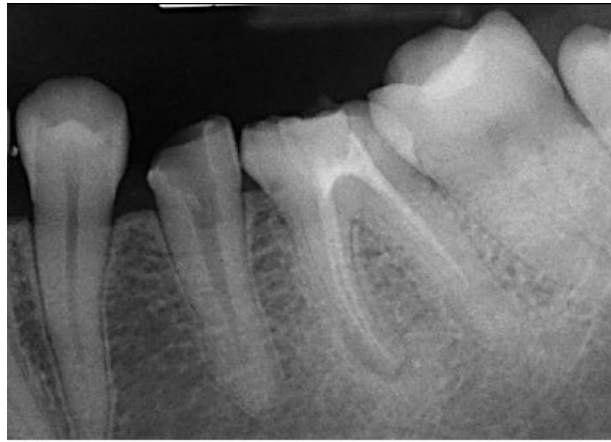
Figure 4) Radiograph shows retrieved the instrument from the canal

Immediately after post-operative radiographs were obtained to verify the complete removal of the fractured instrument (Figure 4). After determining the working length, cleaning and shaping were performed manually. Obturation was done using gutta-percha and AH26 sealer cement using lateral condensation technique (Figure 5). A metal-ceramic crown was placed as the definitive restoration (Figure 6).

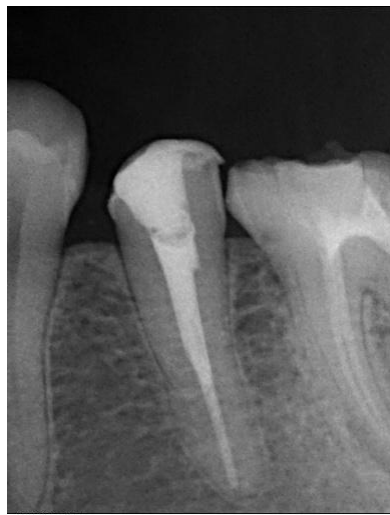
Figure 5) complete obturation of the canal

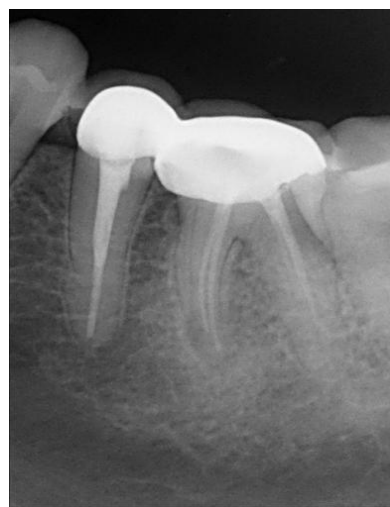
Figure 6) 12-month follow up.
