Regional Study on Historic Monuments

Sreya Das¹, Dr. Biman Mukherjee²

Student of M. Tech in Structural Engineering, Narula Institute of Technology
Professor of M. Tech in Structural Engineering, Narula Institute of Technology

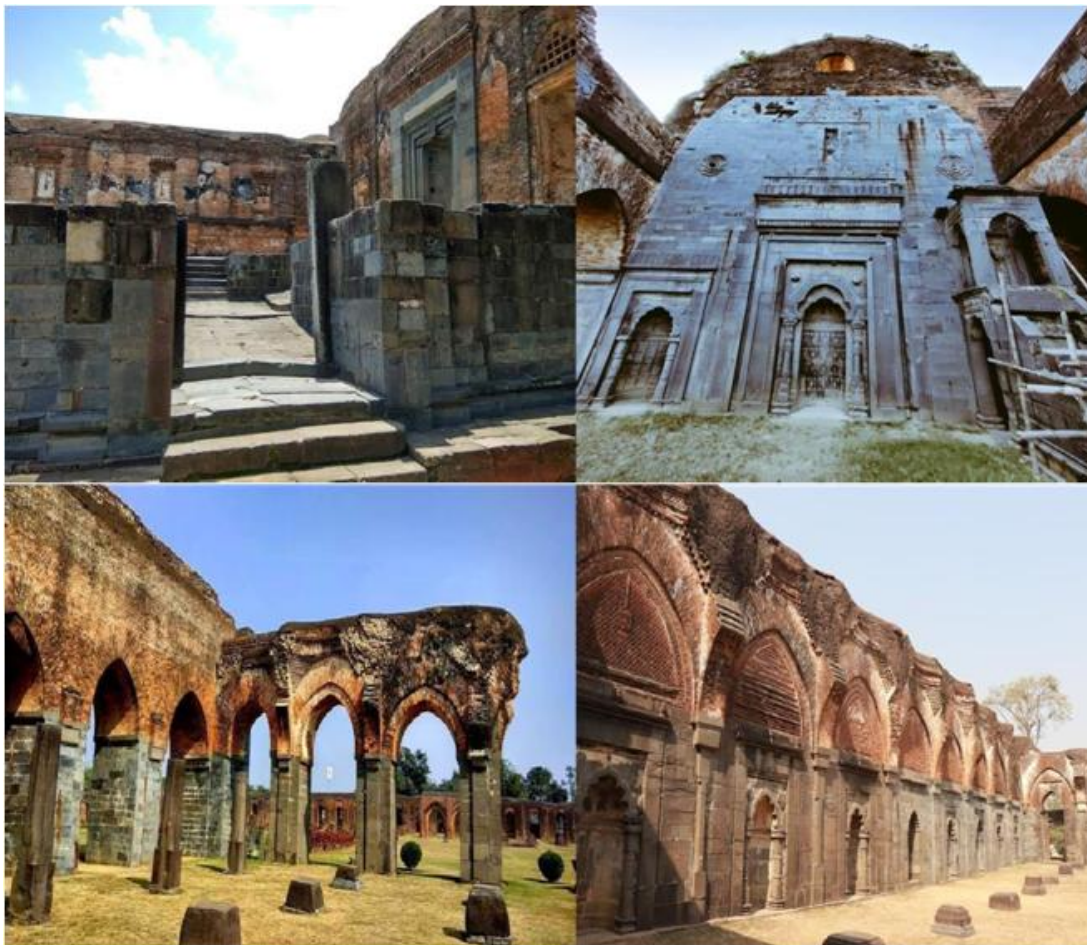
ADINAMOSQUE, PANDUA, MALDA

PHOTOGRAPHIC AFFIRMATION

The foundation of the mosque is made of stones on the lower parts of the walls, and of open bricks on other parts. Its measurement is approximately calculated as 155×87 m externally with fluted column on the corners and 122×46 m internally with the arcade cloisters by the sides of the open space. The 12 m wide cloisters on the north, east and south of the open space are three aisles deep.

It consists of a prayer chamber measuring 24 m in breadth with five aisles; dividing the prayer chamber through the middle. A wide vaulted nave runs perpendicular to the Qibla wall. It measures 21×10 m and was once approximately 18 m high, but due to weathering conditions it is now fallen. The domes of the mosque covering squares formed by stone columns are variously estimated to be 306 and 370. According to Crowe the number is 260. The columns are square at the base, rounded at the middle, and slanting towards the capitals.

The domes are carried by triangular pendentives are now fallen except some on the northern cloisters of the prayer chamber. They were of an inverted tumbler shape with an elliptical curve, typical of the dome used throughout the whole sultanate period. The nave, much higher than the cloisters, was covered by a barrel vault, which because of its loftiness dominated the whole structure, and was seen from a long distance. The front of the vault is much speculated: it hints a rectangular frame like a Persian Iwana or was it open to the apex.
